WIRE COMPANY DAM NO. 2
CT 00601

PHASE I INSPECTION REPORT
NATIONAL DAM INSPECTION PROGRAM

JULY 1981

IDENTIFICATION NO: CT-00601
NAME OF DAM: Wire Company Dam #2
TOWN: Seymour
COUNTY AND STATE: New Haven County, Connecticut
STREAM: Little River
DATE OF INSPECTION: June 2, 1981

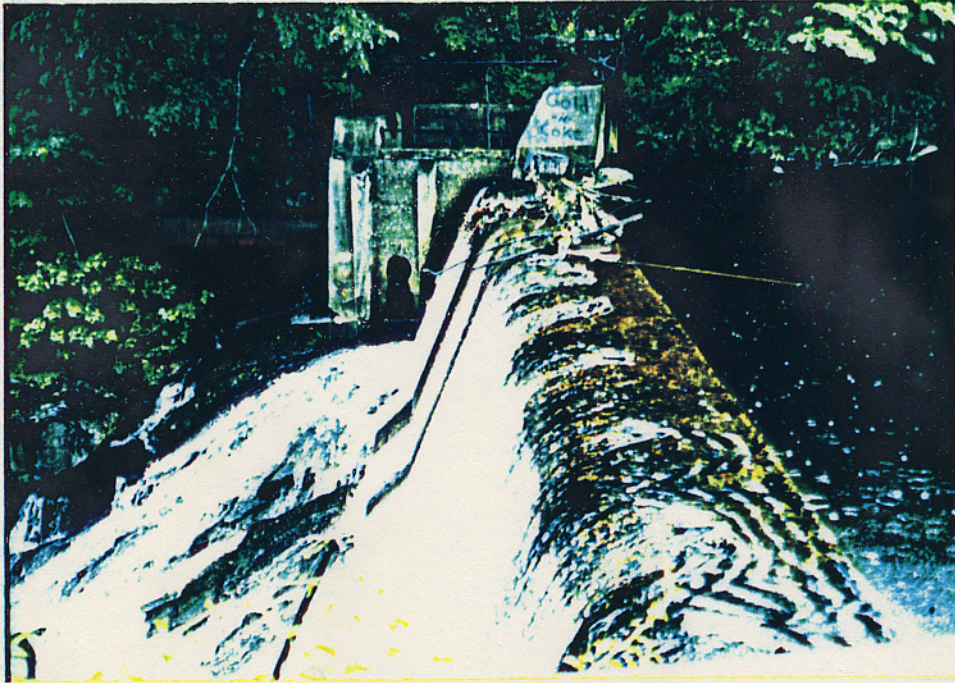
Flow over the spillway partially obscured the dam embankment which was generally in good condition with no indication of cracking (see Photos 1 and 2). Exposed aggregate was noted along the entire length of the spillway with additional deterioration at the junction of the north retaining wall and the outlet works. Inspection of the contact zone between the

As shown in Photo 1, minor leakage was observed outletting from the 18 inch opening on the north face of the chamber. No control works for this outlet were visible nor was its purpose determined. Another opening was noted on the last fascia of the intake chamber (see general plan in Appendix B). Flowing

Several large trees are overhanging the concrete intake chamber and steel outlet pipe as shown in Photo 1. Potentially, these trees could cause severe damage to the pipe and/or chamber which could have an adverse effect on the structural stability of the dam.

Several large trees are located in the vicinity of the outlet works. A falling tree could severely damage the intake chamber and the 36" iron pipe. Potentially, the pipe could be torn from the intake chamber adversely affecting the condition of the structure and downstream gate.

Photo 1 - View across spillway looking south.
Note outlet works.

1. Prepare a formal program of operational and maintenance procedures and fully document to provide accurate records for future reference.
2. Repair the hole and the areas of concrete deterioration at the intake chamber.
3. Fill in low area immediately south of the dam embankment to the level of the concrete wall and provide for adequate protection against erosion.
4. Remove trees within 25 feet of the east face of the intake chamber.
5. Remove brush and debris on crest of the spillway.

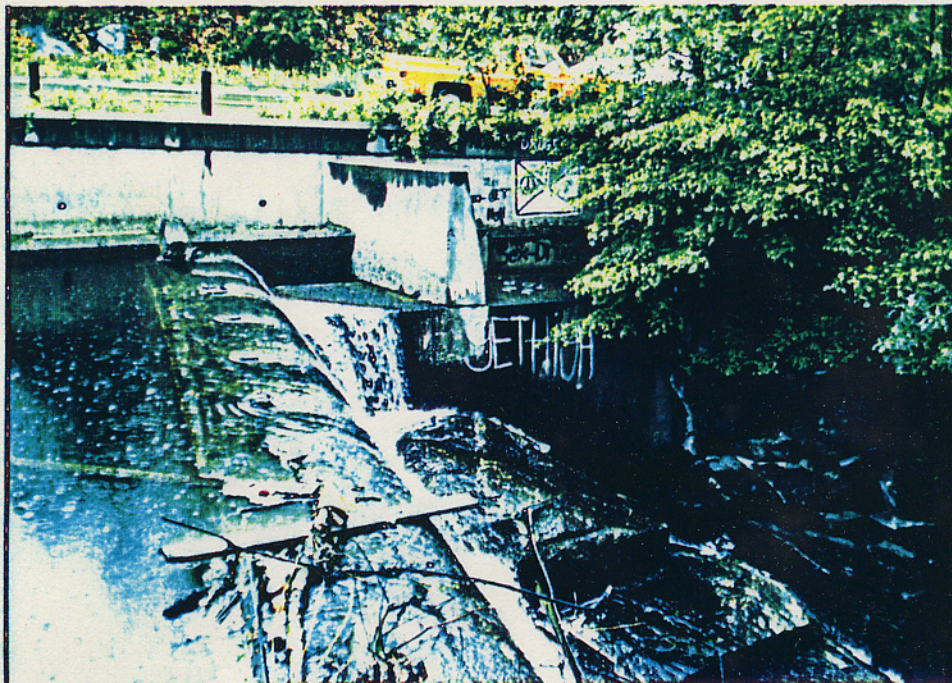
concrete and rock ledge foundation revealed the possibility of undercutting; however, a close inspection of this area was hindered by the continuous spillway flow. Accumulated debris was observed on the crest and at the toe of the dam as shown in Photos 2 and 3.

Photo 2 - Looking north across spillway crest.
Note accumulated debris.

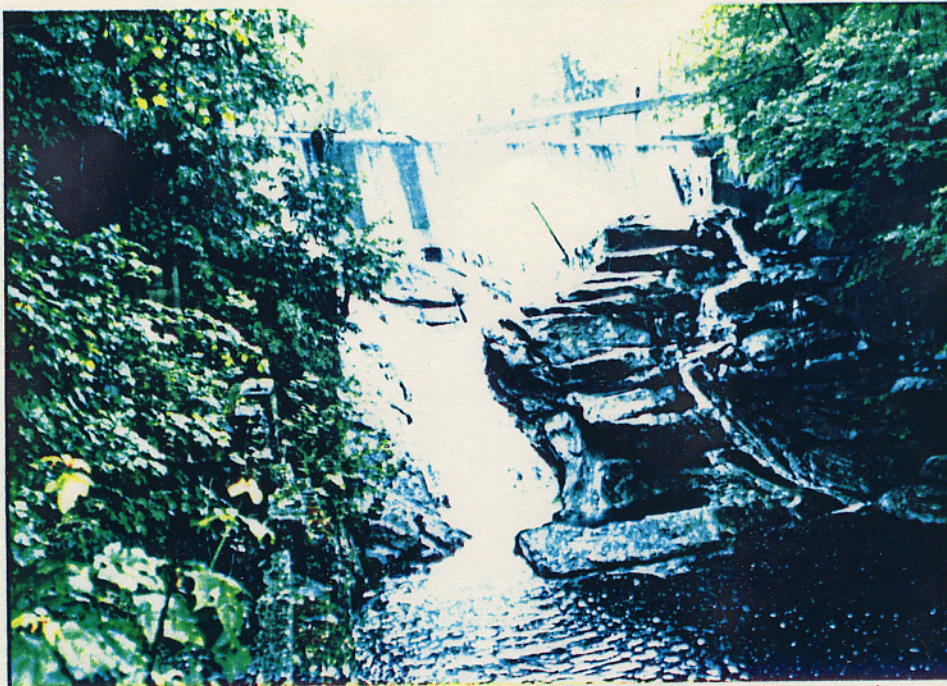
Photo 3 - Face of concrete spillway and rock ledge falls.

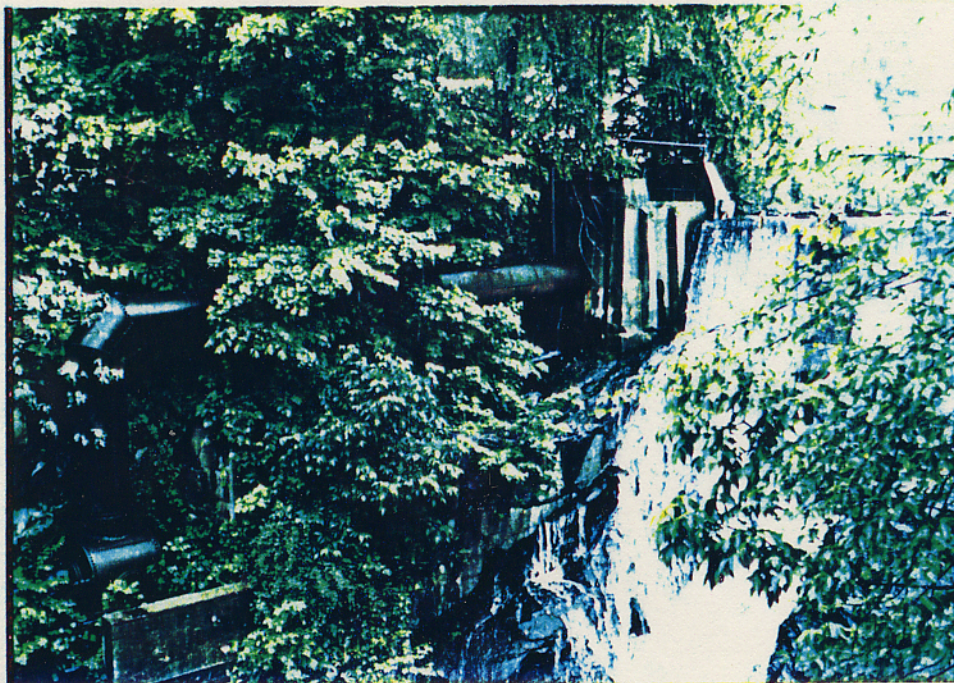
Abutting the south end of the spillway and founded on the rock ledge is the concrete intake chamber which is shown in Photos 1 and 4. Two gates with rusted winch mechanisms are

Photo 4 shows a large 36 inch iron pipe extending from the concrete intake structure to a gutted turbine chamber. Eventually outletting into the downstream channel, the steel plated, rivetted pipe was in fair condition. Excessive leakage of several gallons per minute was observed from the pipe at the junction with the intake chamber accelerating the deterioration of the concrete. The power generation system is presently inoperable with the turbine works removed.

Photo 4 - View of outlet works located along south side of dam.

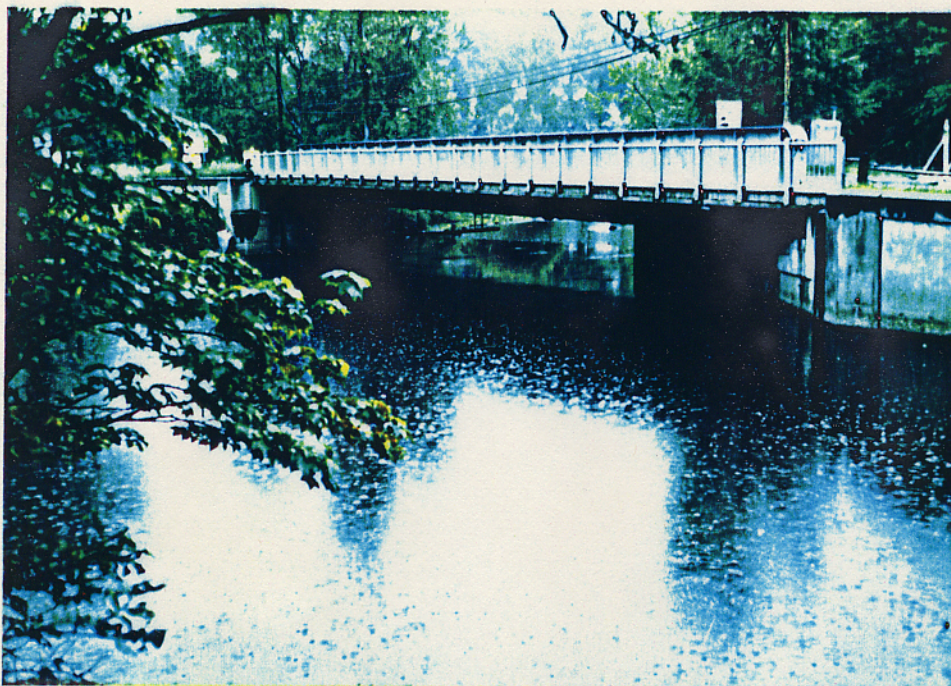
Photo 5 - Upstream area (Little River)

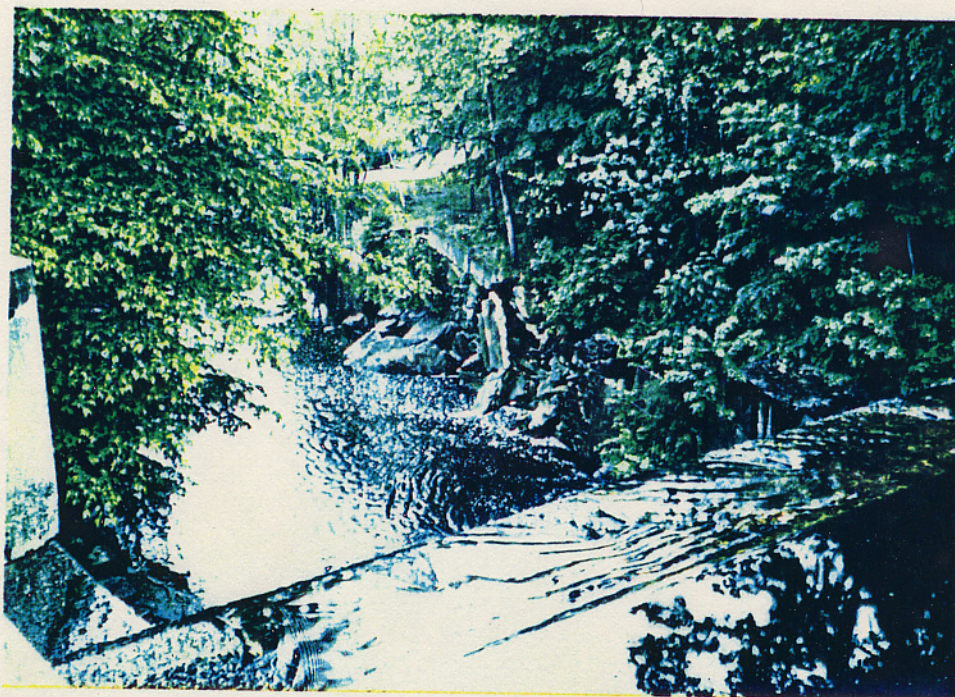
| AREA EVALUATED | CONDITION |
|---|--|
| Loose Rock or Trees Overhanging Channel | Deteriorated rubble wall overhanging South bank. |

Photo 6 - Downstream channel. Note rubble foundation wall along the south channel bank.
